Naufragio Bayesian: pubblicate da Marine Accident Investigation Branch le prime ipotesi sulla cause

Interim report on the investigation into the foundering of the yacht *Bayesian*, with the loss of seven lives, 0.5 nautical miles south-east of Porticello, Italy on 19 August 2024

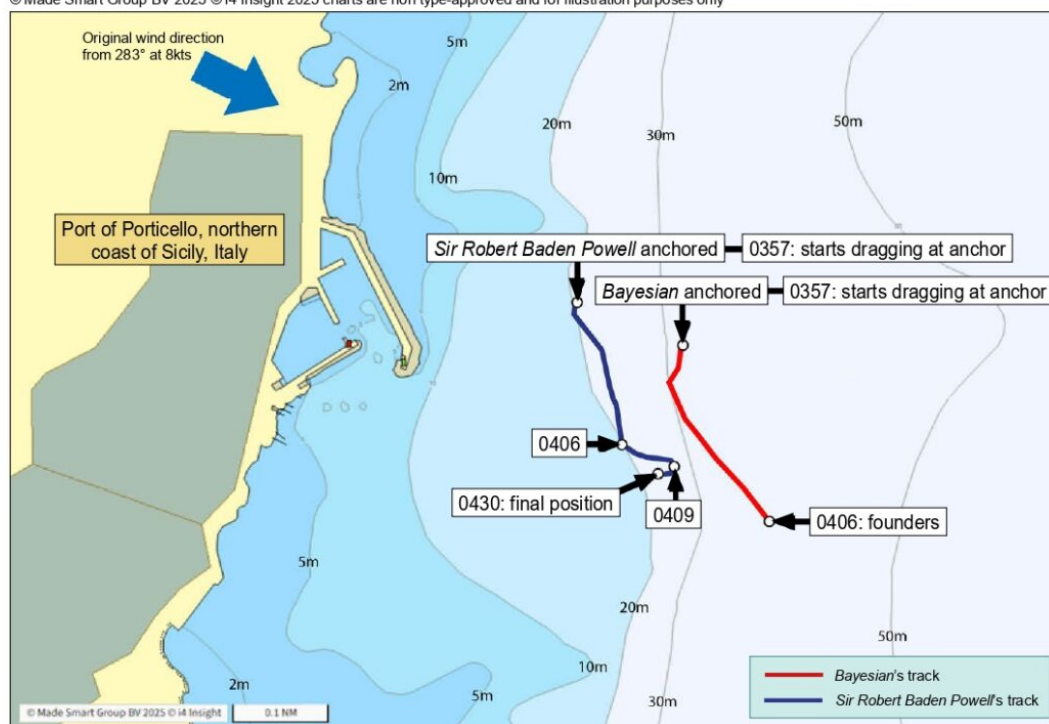
Figure 2: Location and tracks for *Bayesian* and *Sir Robert Baden Powell* on 19 August 2024

Bayesian was lying with the wind about 60° off the port bow and moving at 1.8kts south-south-east of its original position (**Figure 2**). *Sir Robert Baden Powell* was also dragging its anchor at a similar rate in a similar direction.

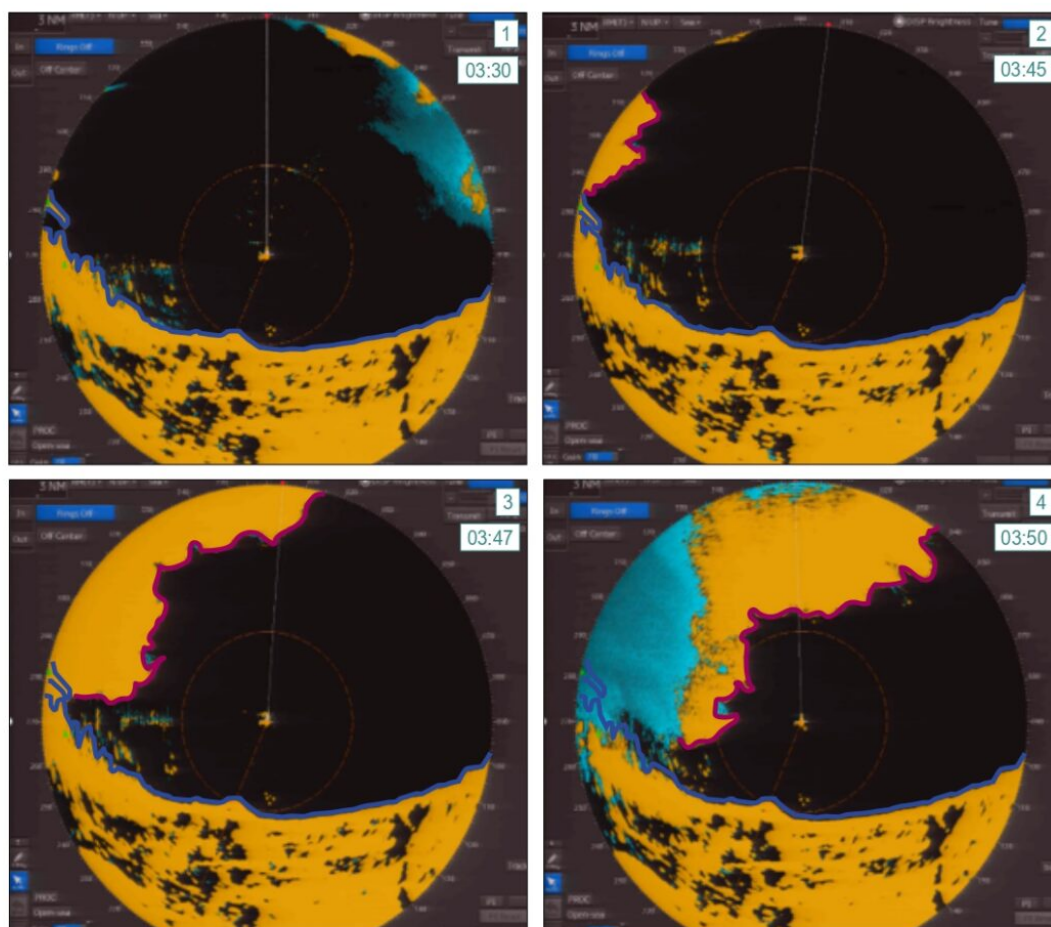
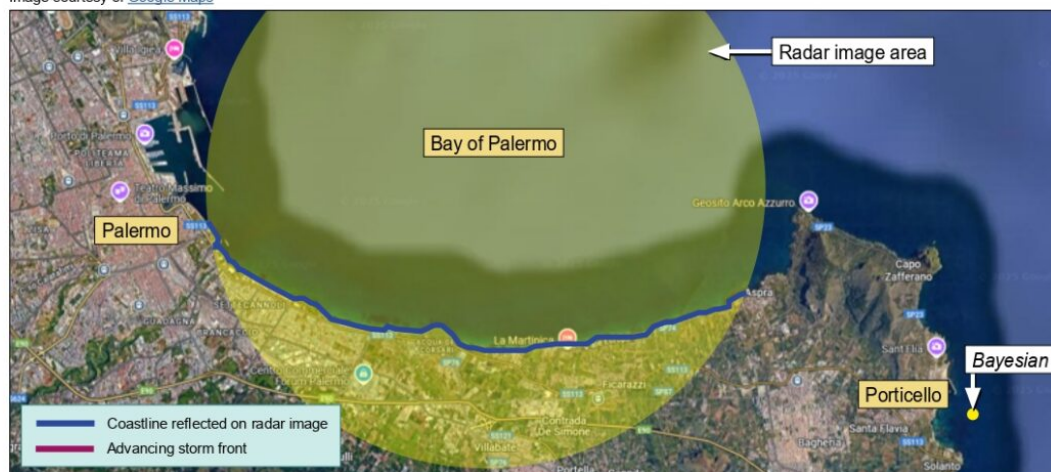
Figure 3: Radar images, showing passage of rain across the Bay of Palermo on 19 August 2024

At 0352 on 19 August 2024, around 5nm to the north-west of the Porticello anchorage, winds were recorded to have suddenly increased from around 5kts to 41kts from the north-west. These strong winds were associated with a storm front that passed quickly towards the rugged coastline near Bagheria and Porticello. This was observed on a nearby vessel's navigational radar (**Figure 3**). Several CCTV cameras in Porticello showed an intense squall of wind and heavy rain arriving, throwing debris around violently before moving on. This intense squall was associated with lightning strikes, thunder and very poor visibility. Land weather readings (recorded at 5-minute or hourly intervals) captured a peaking of wind strength as the intense squall passed.

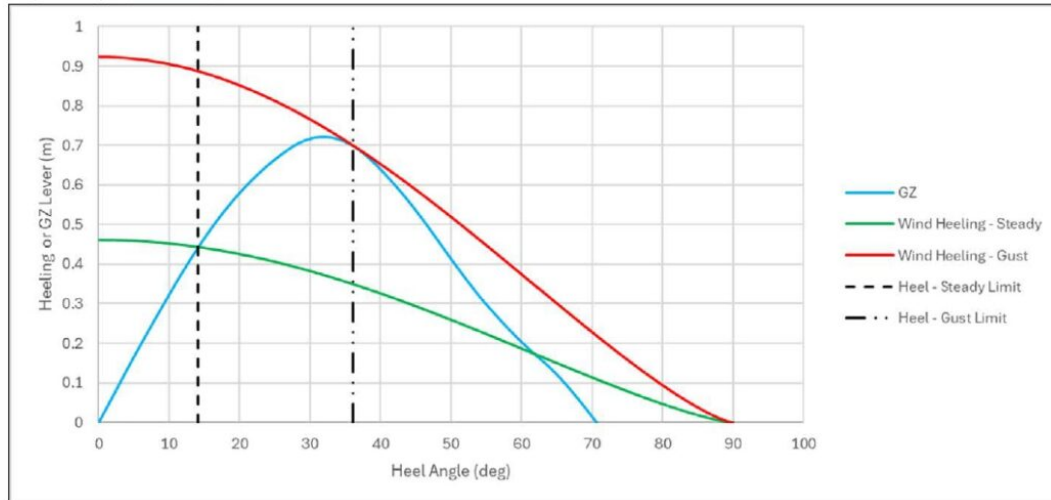
**Figure 4:** Derived wind heel data in assumed loss condition

Examination of a possible loss condition determined that the limiting heel angle¹⁰ for a steady wind was 14.2° and that the limiting heel angle for the associated gust was 36.3° (**Figure 4**). The study predicted the wind speeds that would produce those limiting heel angles for a range of apparent wind angles (AWA) relative to the bows, shown at **Table 1**. The table shows a high limit of wind speed, which included the impact of interactions and blanketing effects between different elements of the mast and rigging. The low limit describes the wind speed required to achieve the limiting heel angle with no blanketing or interaction effects included. Less wind is required to achieve the limiting heel angles if all the different elements of the mast and rigging are treated individually. More wind is required to reach that limiting heel angle when considering the blanketing effect that some of the rigging might have on the mast, for example.

The study indicated that if the wind was blowing directly onto *Bayesian*'s beam and the yacht was in the 'motoring' condition, a gusting wind speed in excess of 63.4kts would likely result in the vessel capsizing, irrespective of any interactions and blanketing effects.

¹⁰ Derived from the wind heeling moment that would cause the vessel to capsize, representing the 'gust' condition. To determine a steady state wind speed condition, this limiting wind speed is divided by the gust factor (1.4142, or the square root of 2). The position where the steady state wind heeling moment curve intersects the GZ curve indicates the limiting heel angle for a steady wind. The limiting heel angle in the gust condition is determined by the position where the gust heeling moment coincides with the GZ curve at its greatest extent (**Figure 4**).
