Naufragio Bayesian: pubblicate da Marine Accident Investigation Branch le prime ipotesi sulla cause

Interim report on the investigation into the foundering of the yacht *Bayesian*, with the loss of seven lives, 0.5 nautical miles south-east of Porticello, Italy on 19 August 2024

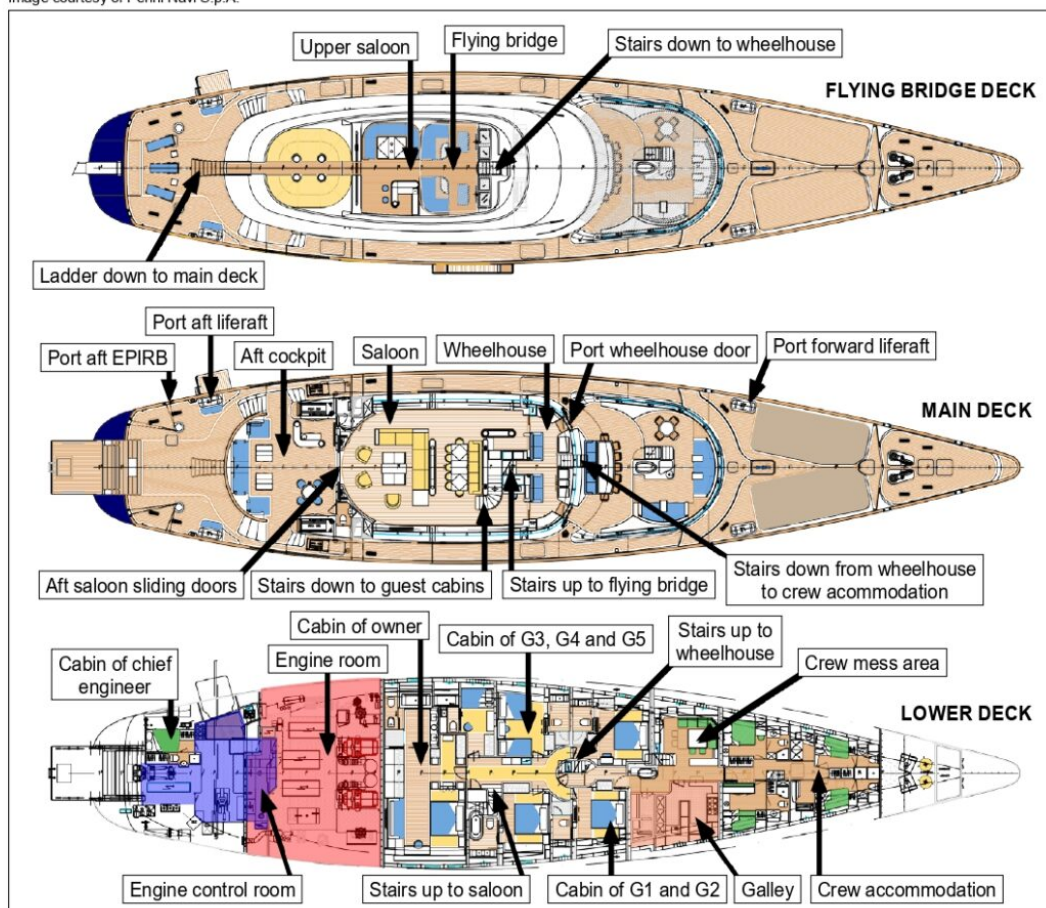
Figure 1: *Bayesian* general arrangement

On 14 August 2024, the privately owned and operated yacht *Bayesian* (**Figure 1**) sailed from the port of Milazzo for a short excursion around the Aeolian Islands and the north coast of Sicily. There were 12 guests and 10 crew on board. The intention was to disembark the guests on 19 August before proceeding to Naples for a period of maintenance. On 18 August, *Bayesian* was anchored at Cefalù on the northern coast of Sicily.
